## Hoist Worm Gear Drives

## Steel Mill Charging Crane

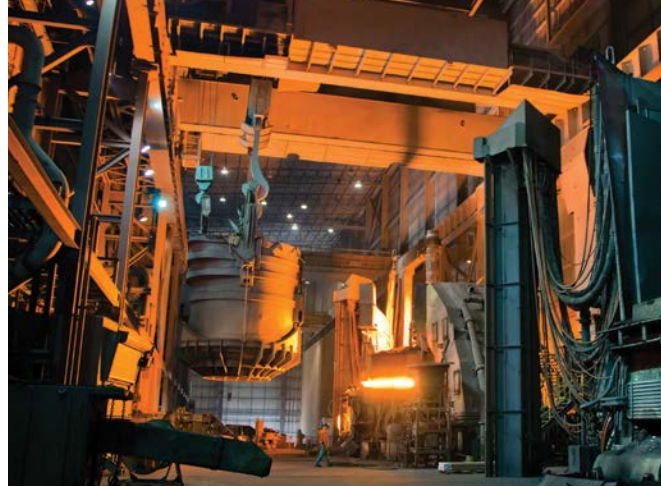
Charging crane hoist drive gear boxes were failing prematurely at a large steel mill in Northeastern U.S. The failures were causing unfavorable outages and expensive periods of downtime.

Based on their findings, Delroyd engineering developed new worm gear sets utilizing aluminum bronze gears and redesigned the bearing mountings to enhance strength and durability. A carburize hardened, ground and polished alloy steel worm develops a smooth, work-hardened surface on the aluminum bronze gear. Extra-heavy side plates were used to connect the worm and gear shaft bearing supports, assuring proper meshing of the gear under all conditions of load. A more rigid fabricated steel housing design was utilized to reduce bending moment stresses. A redesigned, more efficient lubrication system was also incorporated.

The Delroyd design changes resulted in extending the gearbox life by over five years. The charging crane gearbox success prompted the mill to utilize Delroyd's expertise by providing gearboxes for their gantry cranes as well.
